## **CASE STUDY – Cavity Wall Insulation for Flood Resilience at Bank**

**BUFCA SUPPLIER:** Isothane Ltd  
**BUFCA INSTALLER:** A & R Hepburn (Engineering) Ltd

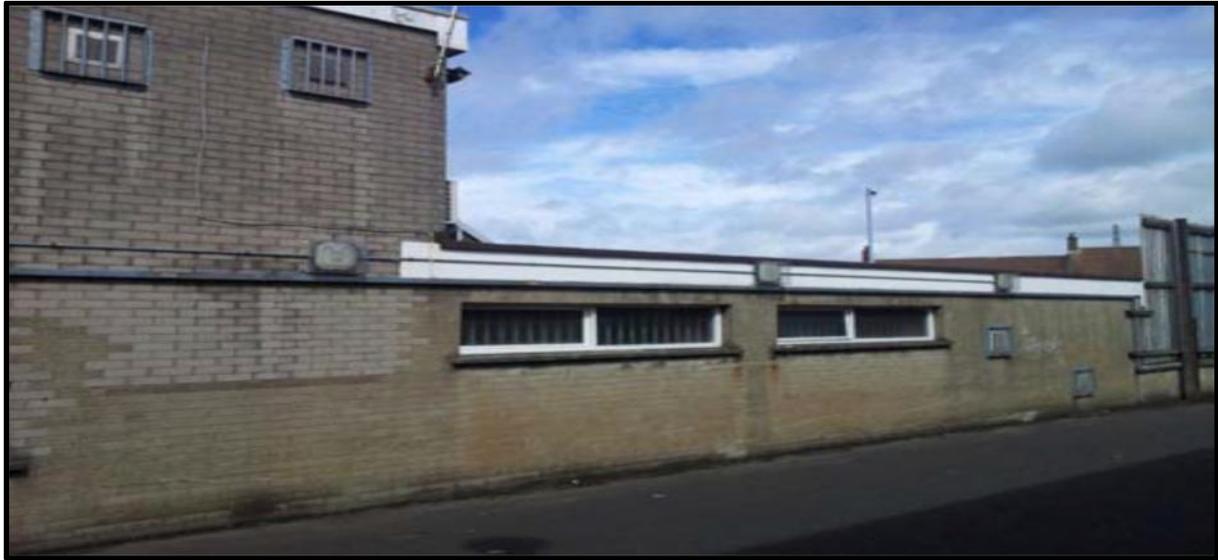
The Bank of Ireland is situated next to an industrial estate where the road in to the estate is one and a half metres above the ground level of the bank. During the winter snow storms, the snow drifted against the side wall of the bank, and this was added to as more piles of snow from the roads being cleared were put against the side wall.

As the snow melted, the melt waters soaked through the outer brick leaf of the side wall and into the cavity. This was exacerbated by the wind driven rain against the wall and resulted in the cavity flooding and the water soaking through the inner leaf of the cavity, causing severe dampness on the inner walls of the bank. The job requirement was to dry out the walls and find a flood resilient material which would also insulate the cavity to a high standard. There was also concern that the flooded cavity might have structurally weakened the wall.

To dry out the walls, some outer leaf bricks were removed from the side wall and rubble in the cavity was cleaned out to a depth of 300mm and the bricks were replaced. Technitherm was then installed into the cavity to form a flood resilient cavity wall insulation barrier. This closed cell insulation material has been independently tested to prove its flood resilience, so was able to prevent further ingress of water and solve any structural problems caused by the flood waters.

The walls of the Bank are now flood resilient, removing any further danger of dampness on the inner walls. Technitherm has also provided insulation values which match Building Regulations and eliminated any structural problems caused by flooding.
