CASE STUDY – In-situ high strength PUR for stabilisation of bridge structure

BUFCA SUPPLIER: Isothane Ltd
BUFCA INSTALLER: Cosyhome

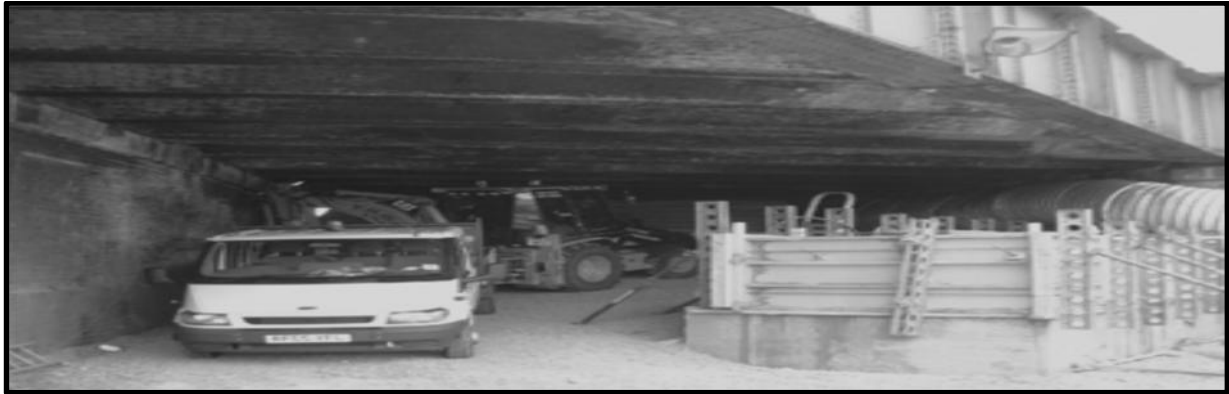
Figure 1: Bridge arch before stabilisation

Duratherm spray applied high strength stabilising PUR was applied to the brick jack arches, stabilising the brick structure before filling the remainder of the void with high strength concrete.

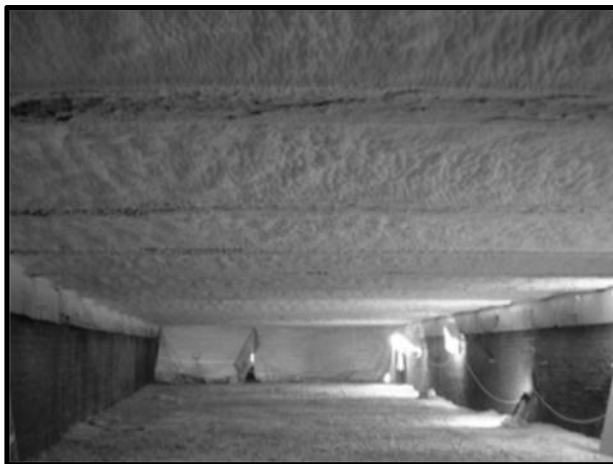
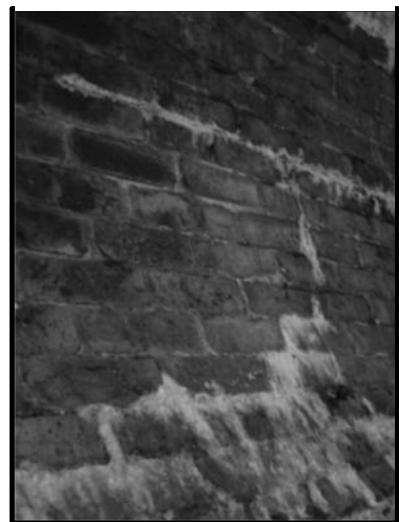
Figure 2: Bridge arch after stabilisation

All works were carried out from below with no disruption to roads, footpaths or car parks. There is no requirement for future inspection or maintenance.
