CASE STUDY – NAIL FATIGUE ON SLATE ROOF

BUFCA SUPPLIER: Edu-Chem Ltd
BUFCA INSTALLER: Roofing Insulation Services Ltd

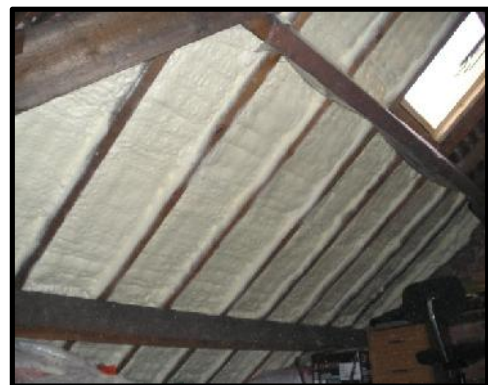
This 1930's terraced house with its original slate roof was starting to cause problems for the homeowner as the original fixing nails holding the slates in place had started to perish. This caused the slates to slip out of position and fall from the roof. Due to the nail fatigue problem, the roof was leaking in different places and the homeowner could not re-decorate his house until the problem was solved. Despite numerous, sometimes costly, repairs carried out to the roof, the problem did not go away.

The chosen installer for the project carried out a thorough survey of the roof and determined the exact problems that needed to be rectified, they also specified sprayed insulation to be installed to the underside of the roof once all remedial repairs had been carried out in order to offer the homeowner a guarantee that the problems would be solved.

Once the roof had been suitably repaired, the installers applied a 50mm covering of EduFoam C150 to the whole of the underside of the slate roof. As the material is spray applied as a liquid, the foam adheres to all surfaces of the slate before curing to form a rigid layer of polyurethane insulation. Due to the unique nature of application, the insulation not only forms a monolithic layer of thermal insulation but also removes the need for fixing nails completely by holding the slates together and to the roof structure. On completion of the works, the homeowner received a 25 year guarantee on the roof which also comes with 10 year insurance backing to provide complete peace of mind.
