## CASE STUDY – NAIL FATIGUE ON SLATE ROOF

**BUFCA SUPPLIER:** Edu-Chem Ltd  
**BUFCA INSTALLER:** Roofing Insulation Services Ltd

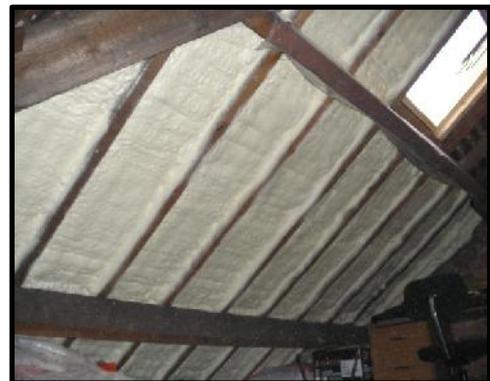
This 1930's terraced house with its original slate roof was starting to cause problems for the homeowner as the original fixing nails holding the slates in place had started to perish. This caused the slates to slip out of position and fall from the roof. Due to the nail fatigue problem, the roof was leaking in different places and the homeowner could not re-decorate his house until the problem was solved. Despite numerous, sometimes costly, repairs carried out to the roof, the problem did not go away.

Once the roof had been suitably repaired, the installers applied a 50mm covering of EduFoam C150 to the whole of the underside of the slate roof. As the material is spray applied as a liquid, the foam adheres to all surfaces of the slate before curing to form a rigid layer of polyurethane insulation. Due to the unique nature of application, the insulation not only forms a monolithic layer of thermal insulation but also removes the need for fixing nails completely by holding the slates together and to the roof structure. On completion of the works, the homeowner received a 25 year guarantee on the roof which also comes with 10 year insurance backing to provide complete peace of mind.
