### CASE STUDY – In-situ Insulation for Fishing Boats

**BUFCA SUPPLIER:** Isothane Ltd

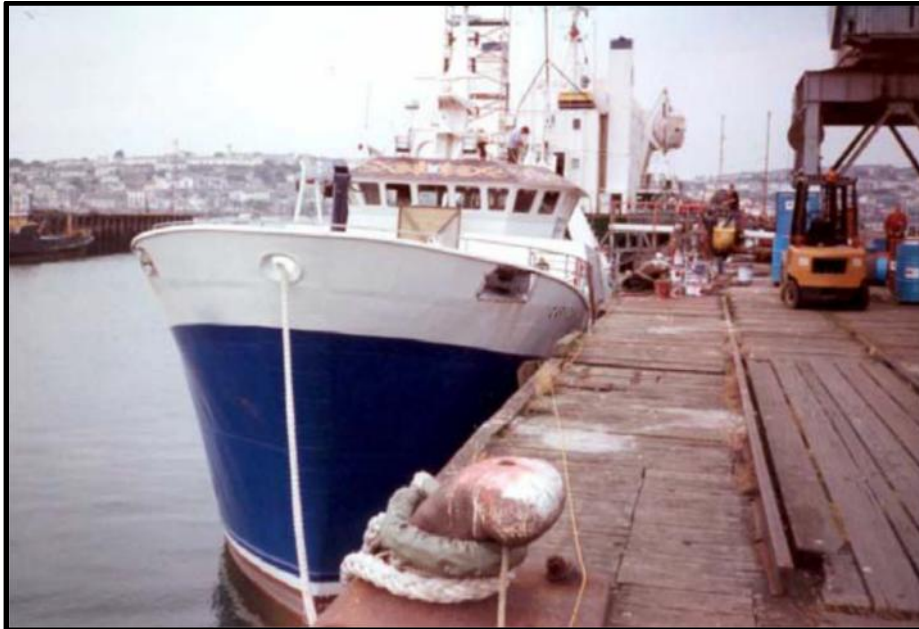
The Carvida fishing vessel required insulation of the ice room, where fish are boxed and stored after catching until they are brought to shore. Excessive condensation and high energy costs for the refrigeration were also important issues.

The walls and ceiling of the 12m x 7m room were lined with timber and the floor concreted.

Isothane LD40 was used to fill the void behind the panels, and between the panels and hull. To help plan the installation, a metal rod was used to gauge the varying depth of the void.

The high insulation value of the spray foam meant that the efficiency of refrigeration was dramatically improved. This in turn reduced the costs of energy consumption and ensured that all the fish were fit for sale on shore. The condensation problems were also eliminated. The ease and speed of installation of the insulant meant that down time from fishing was minimised.
