CASE STUDY – Hard-to-Treat Roof Solution for Village Hall

BUFCA SUPPLIER: Isothane Ltd

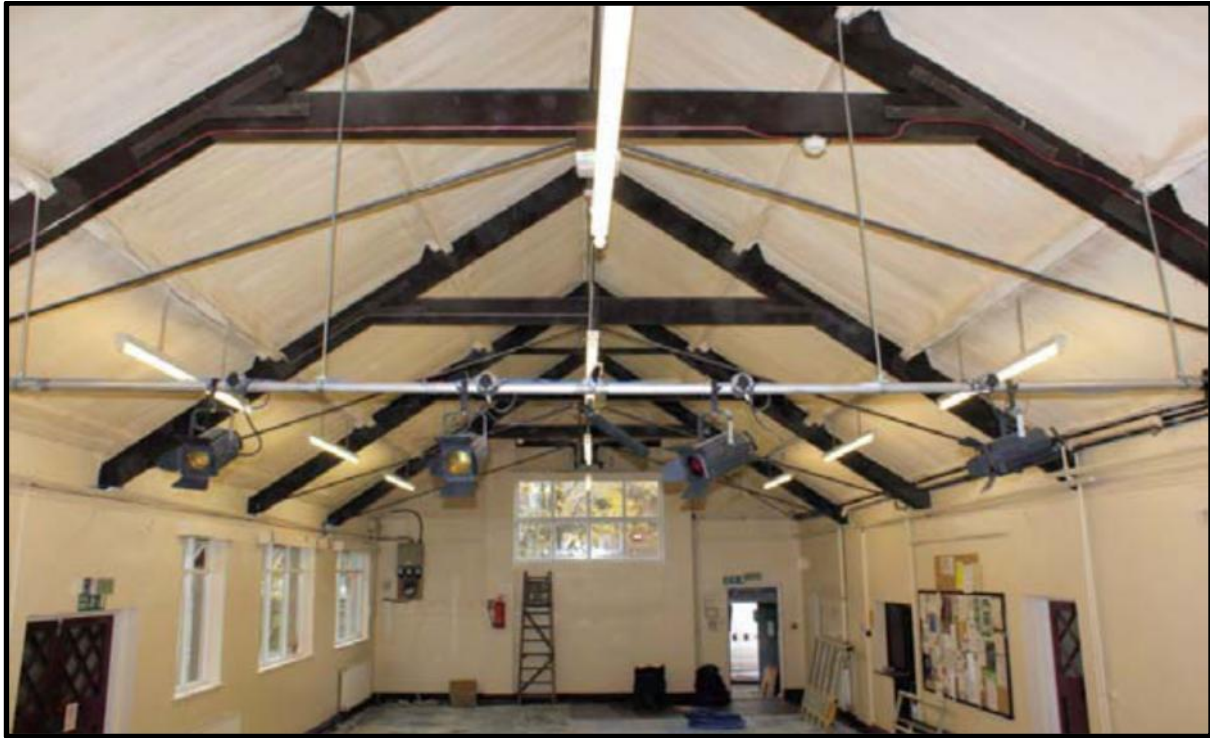
Figure 1: A traditional village hall in Newport

Newport Village Hall in Hull is a large village hall, with a traditional barn style roof, which suffered from major heat loss.

With clay tiles on the outside and smooth painted timber plank on the inside, there are not many options for insulating this traditional building without losing the original features, and keeping within budget.
