CASE STUDY – Waterproof Buoyancy Foam for Marine Installations

BUFCA SUPPLIER: Isothane Ltd
BUFCA INSTALLER: Modern Plan Insulation Ltd

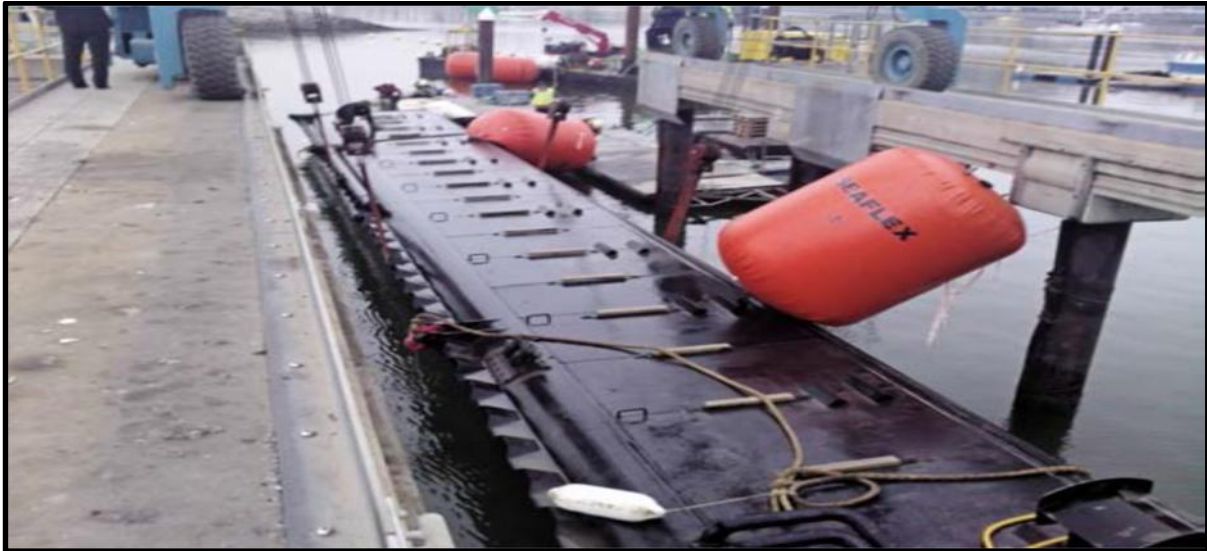
A 25 metre long tidal control gate was internally waterlogged, due to the originally installed open cell foam which absorbed water from a small leak. This prevented the gate from operating correctly.

The gate was removed from the water, the waterlogged foam was removed and the tube fully cleaned and dried. Isothane LD40 was injected through drill holes along the tube, fully filling the holding tube.

The material has a closed cell structure and will not absorb water should a leak occur again in the future. The gate was refitted and tested, and now operates effectively.
