## CASE STUDY – INSULATION OF GRAIN STORAGE BUILDING

**BUFCA SUPPLIER:** Edu-Chem Ltd  
**BUFCA INSTALLER:** Roofing Insulation Services Ltd

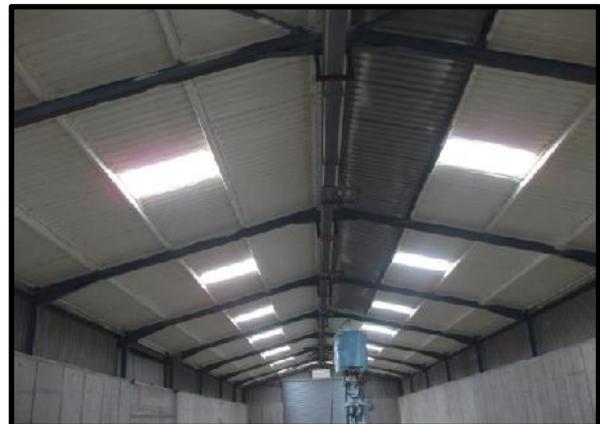
The insulant was spray applied as a liquid to the internal surfaces of the roofs and walls of the building. This allows the foam to adhere to all the contours of the roof before curing to form a rigid layer of thermal insulation. In this case the foam insulation was applied to a depth of 50mm throughout the buildings: this depth eliminates all condensation – even in harsh winters – as well as providing dramatic improvements in overall insulation levels and energy efficiency. Another benefit of using polyurethane foam insulation on this project was the improvement in structural strength of the roof. Shortly after the installation of foam, the area was hit by strong winds and neighbouring farms lost some of their cladding sheets, however these buildings remained fully intact.

The solution to insulate old fibre cement sheets was to use EduFoam: this not only provides excellent thermal insulation properties but also eliminates and prevents the future build-up of condensation on the internal surface of the cladding. Using this system also saves the building owner valuable time and money when it comes to insulating these older buildings.
